Eagle Property Inspection Report

Property Address:

Sunnyside Rd

Inspected on Mon, Jul 24 2017 at 3:00 PM

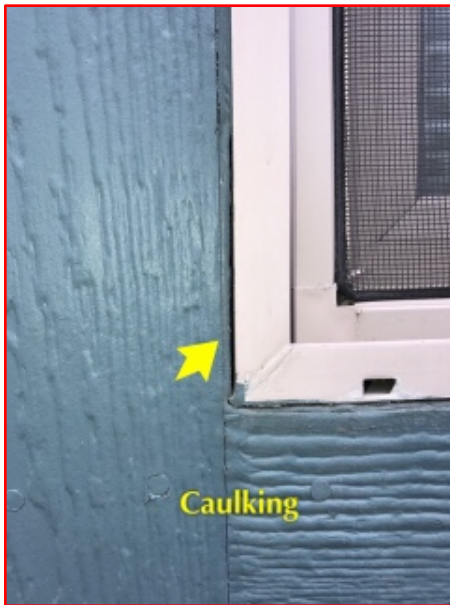
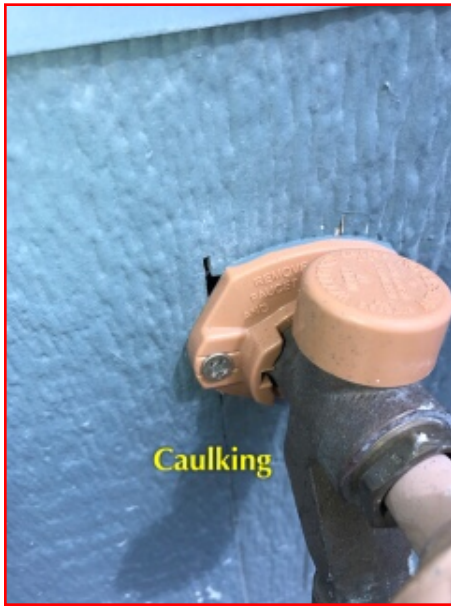
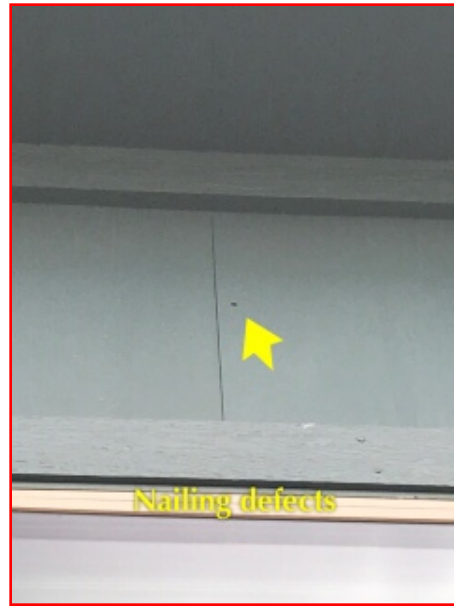
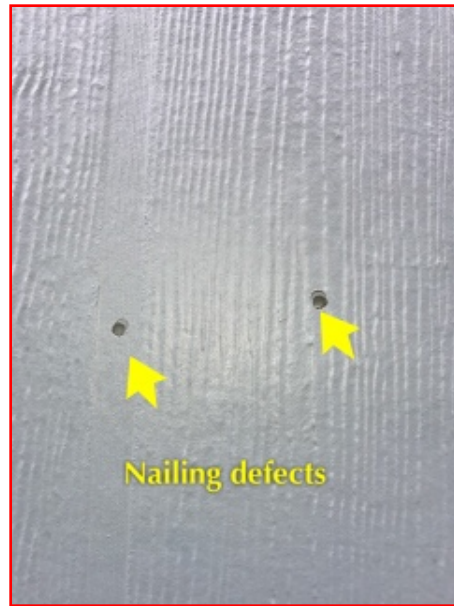
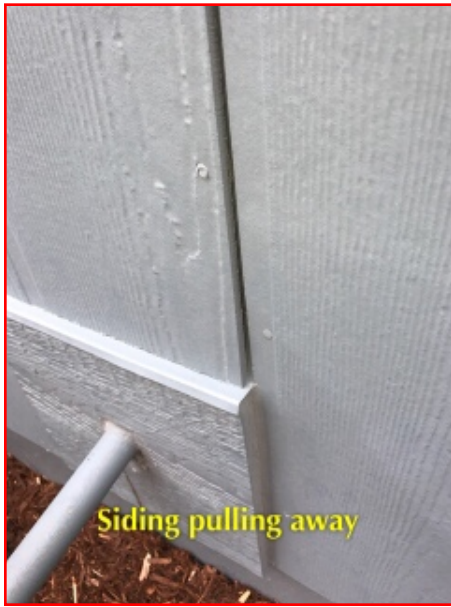
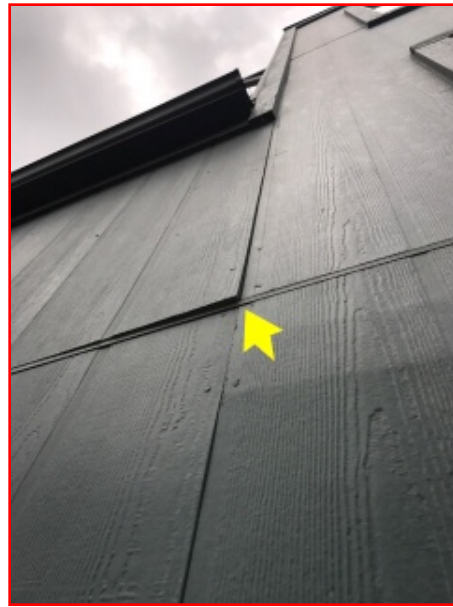
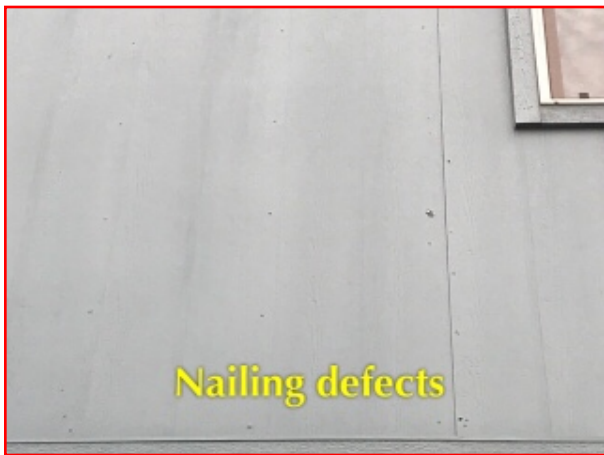
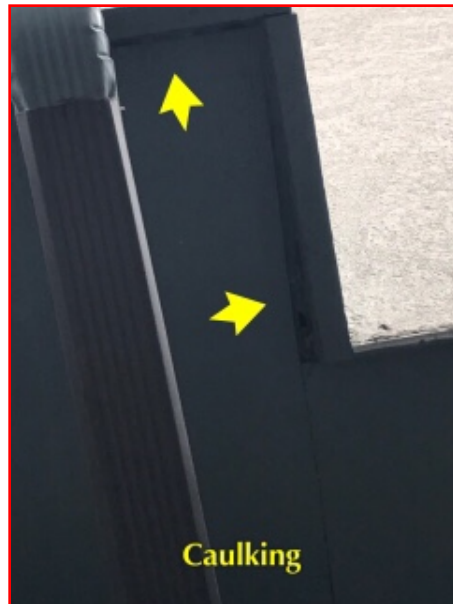
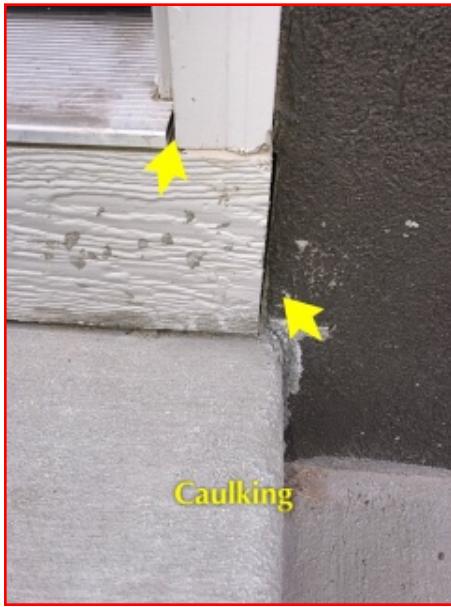
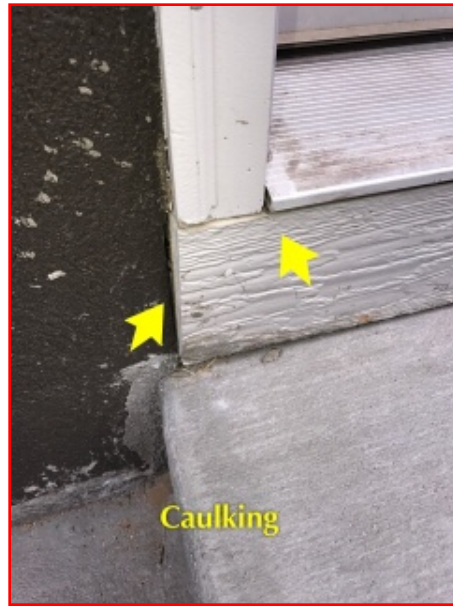
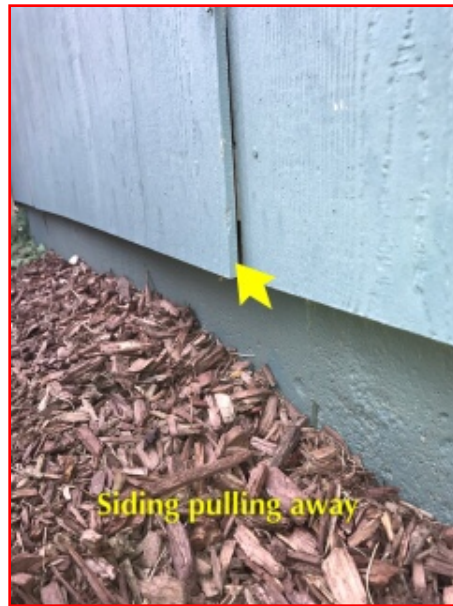
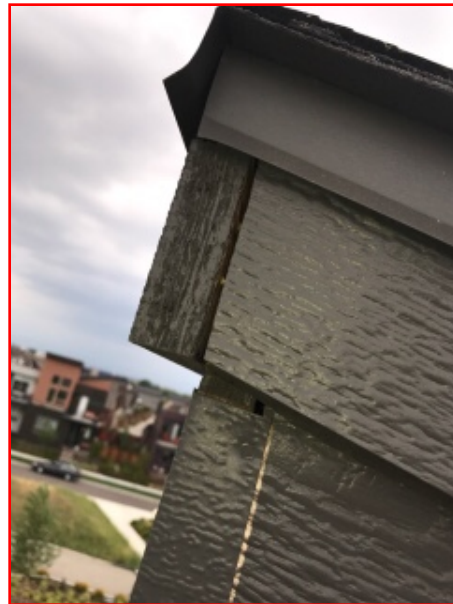
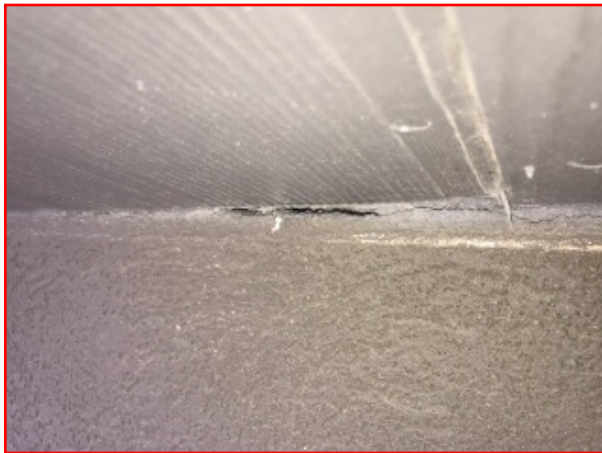
1) Paint needed to trim, siding, soffits, fascia, and any other wood components around house to protect material from moisture. This includes the bottom sides of siding/trim and other wood components on exterior. Recommend caulking any voids around penetrations into the wall, and around windows and doors. This will help provide a seal in these voids that would otherwise allow moisture to penetrate.

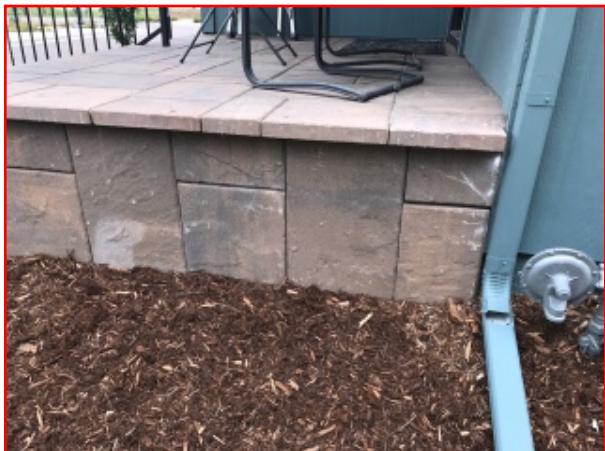
Figure 4-1

4) Several of the pavers around the front porch are loose, dislodged.

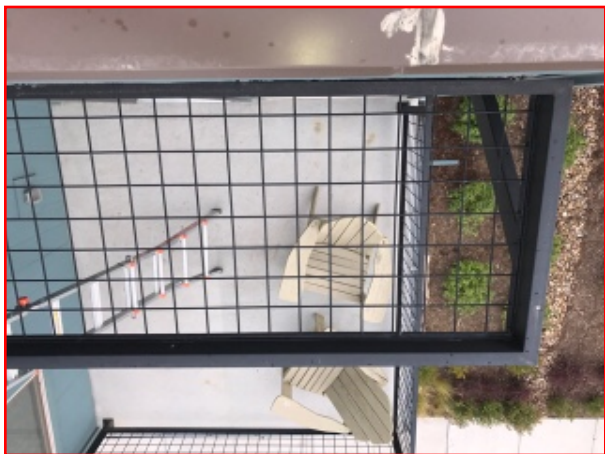
Figure 5-1

5) Metal awning appears to be pulling away from the side of the house.

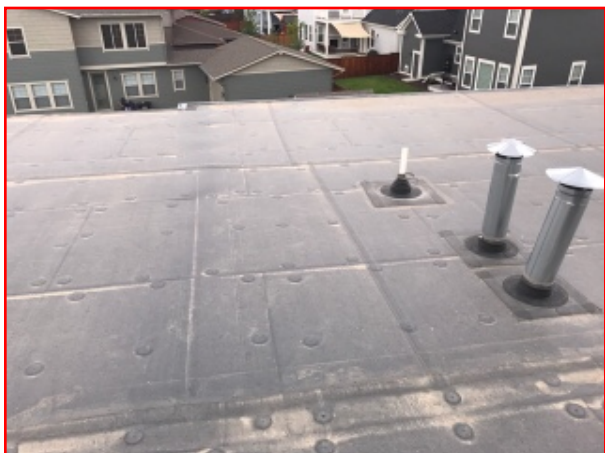
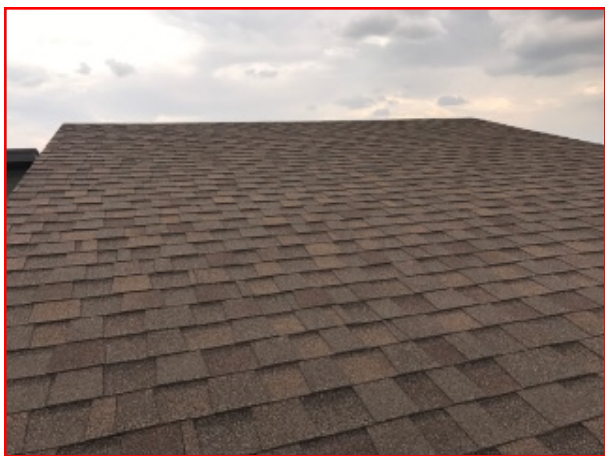
6) Z flashing on very top roof for dimensional shingles does not properly cover attic or roof.

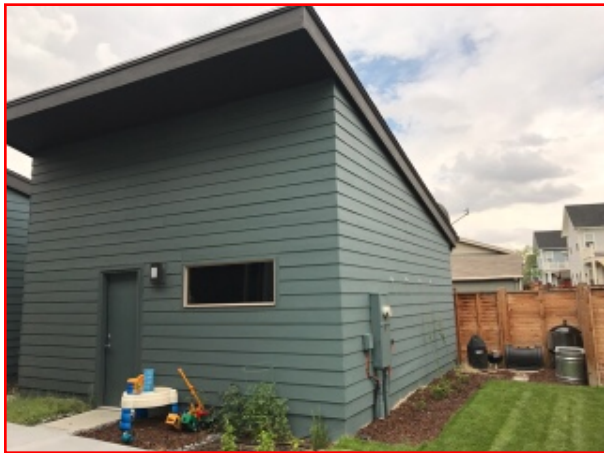
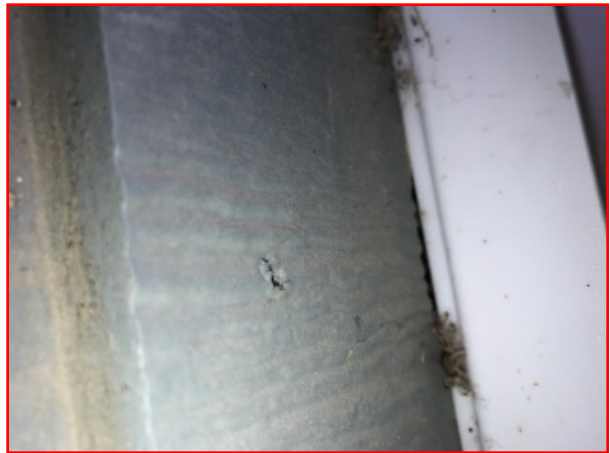
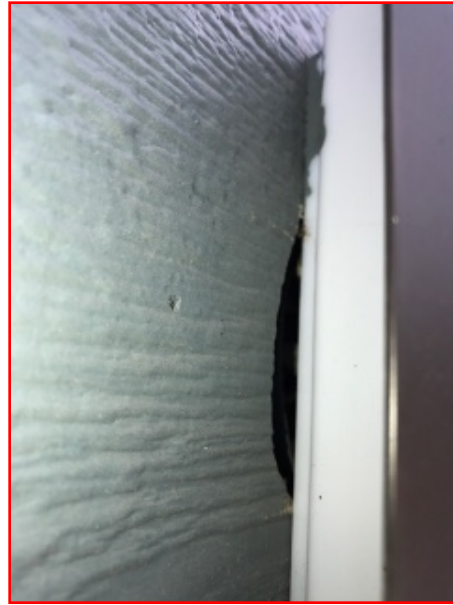
7) Exterior lights on garage do not fully cover junction box behind fixture. This will allow moisture to enter.

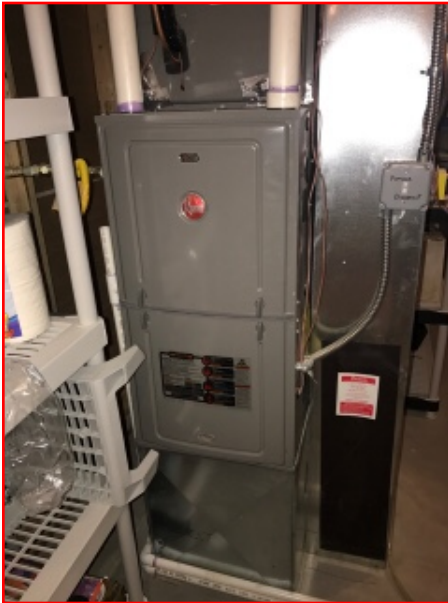
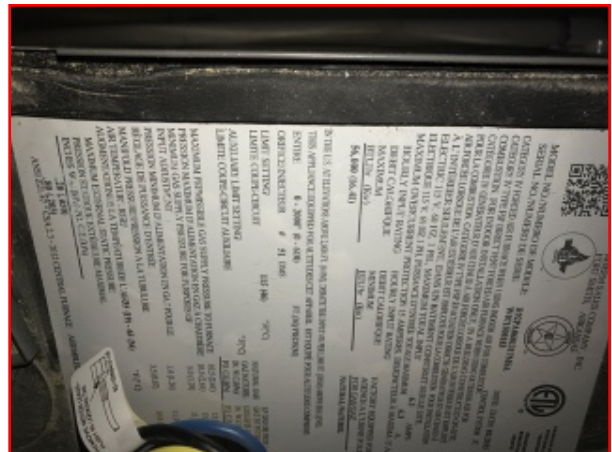
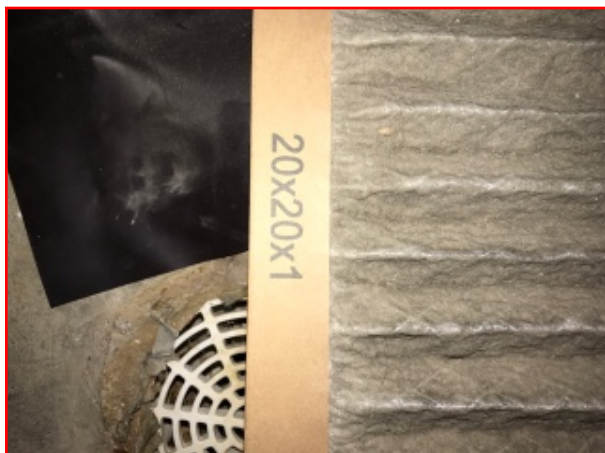
8) Furnace does not appear to have been cleaned/serviced annually. Recommend having a licensed HVAC technician fully evaluate, clean, service, and certify (the certification means pulling the blower motor and fan out of the unit and cleaning) system, and correct any other issues as needed. It is recommended that all HVAC systems be cleaned and serviced annually.

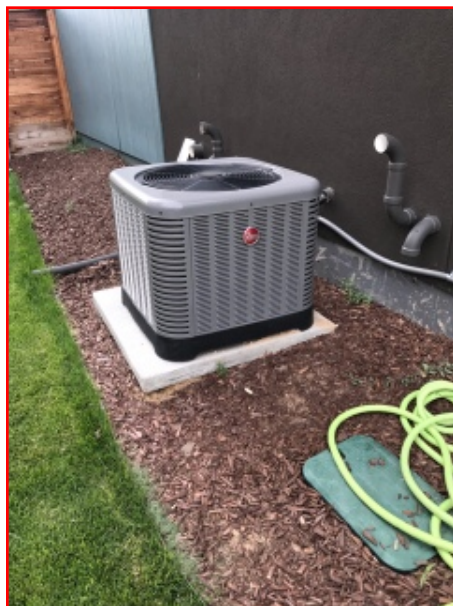
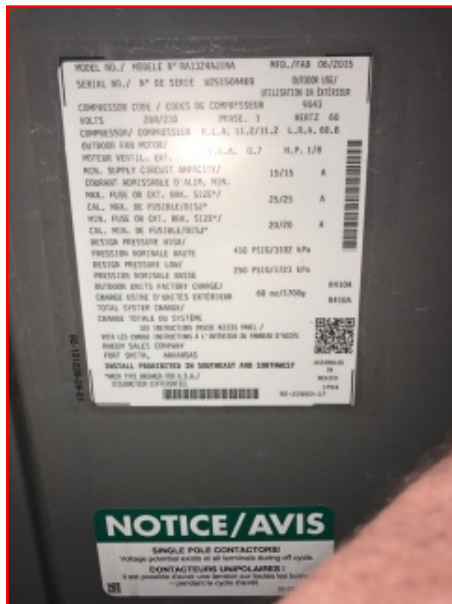
9) A/C compressor not level. This puts wear on moving components. Recommend leveling.

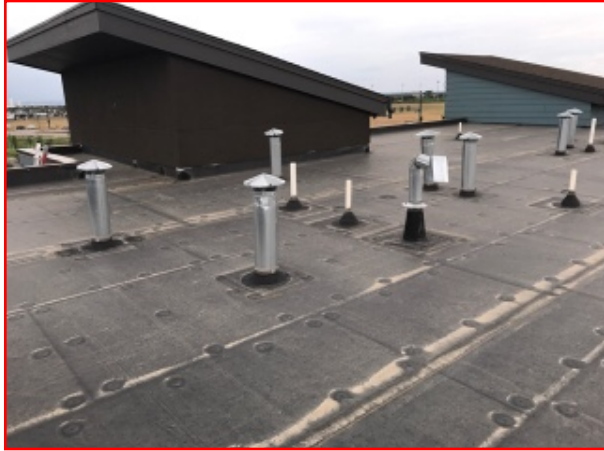
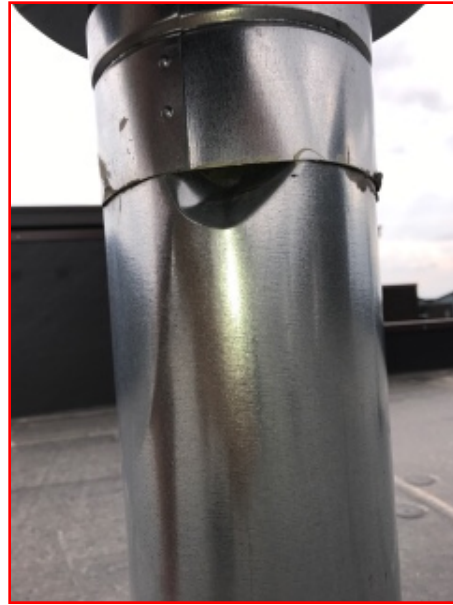
11) Many of the flue pipes are damaged where flue pipes are connected. This can allow bees, wasps and birds to enter and make nest that may prevent flue pipes from venting properly.

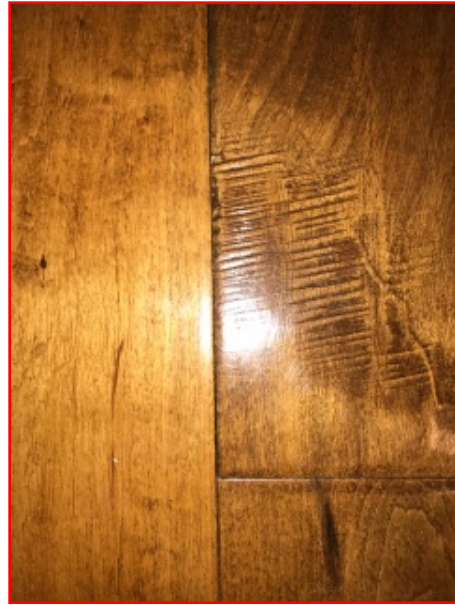
Figure 30-2

13) Wood floors are drying and separating at joints. Flooring is popping and do not appear to have been glued down properly. Wood floors may not have been acclimated properly. Wood floors will need removed and re-installed to fix/correct the problem.

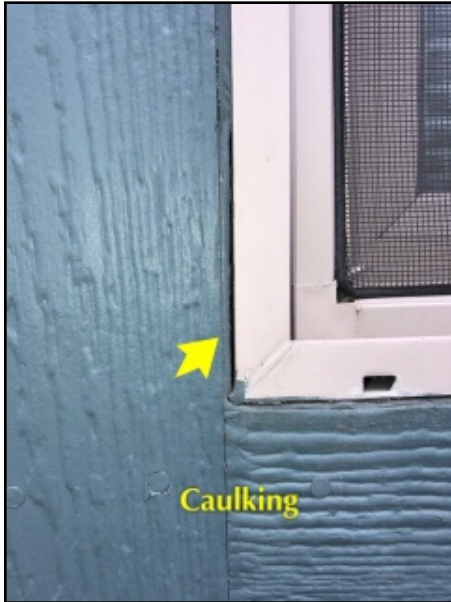
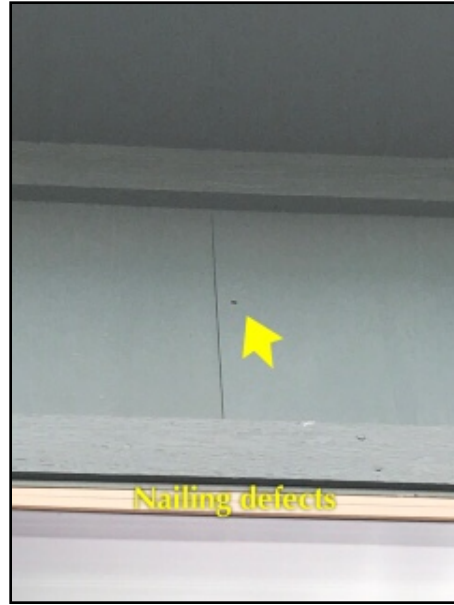
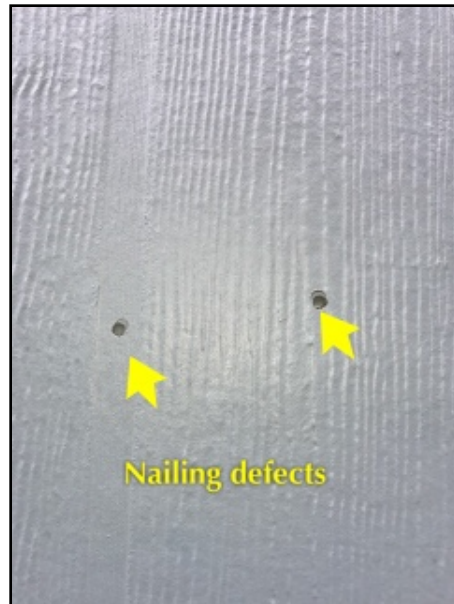
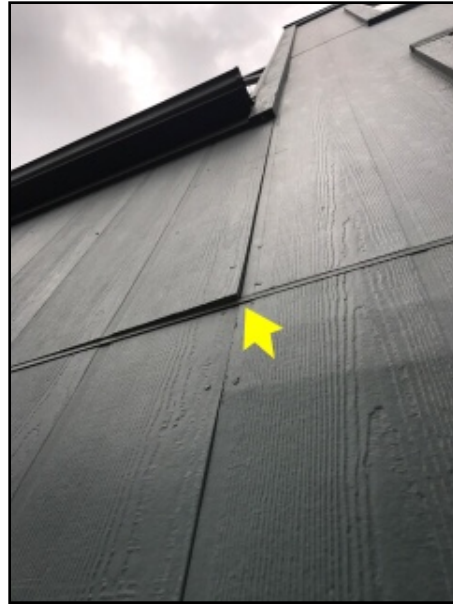
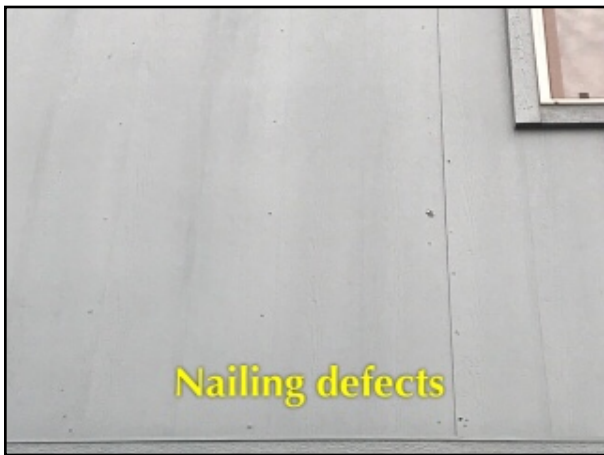
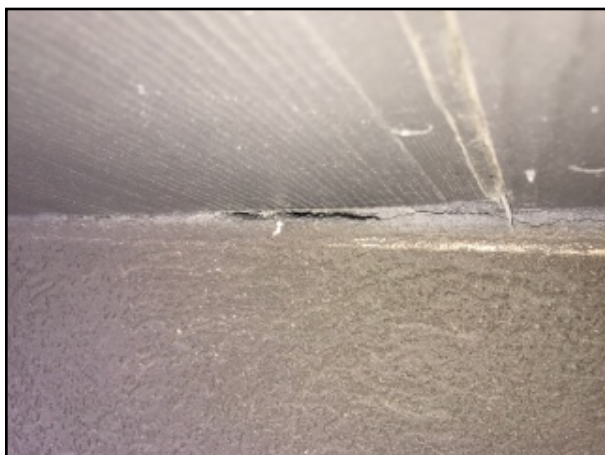
Paint needed to trim, siding, soffits, fascia, and any other wood components around house to protect material from moisture. This includes the bottom sides of siding/trim and other wood components on exterior. Recommend caulking any voids around penetrations into the wall, and around windows and doors. This will help provide a seal in these voids that would otherwise allow moisture to penetrate.

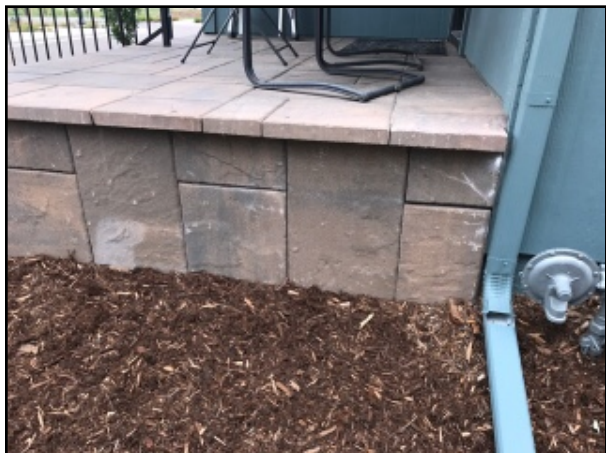
Figure 4-1

Several of the pavers around the front porch are loose, dislodged.

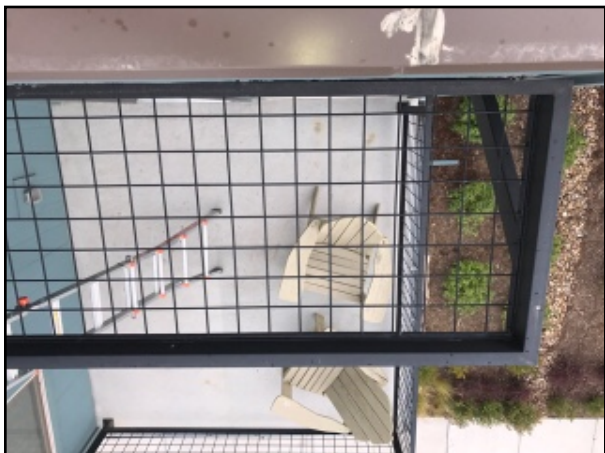
Figure 5-1

**Comment 5:**
Metal awning appears to be pulling away from the side of the house.

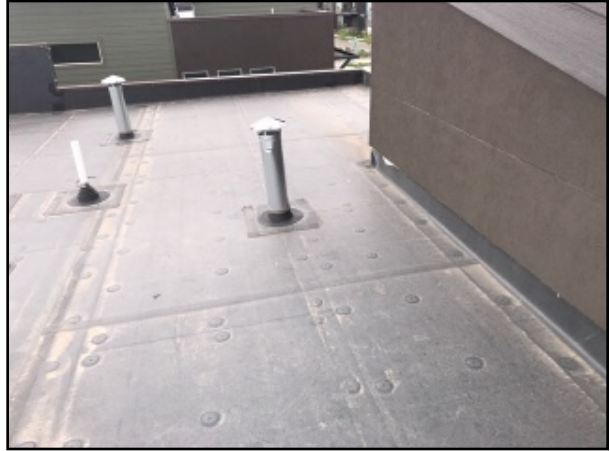
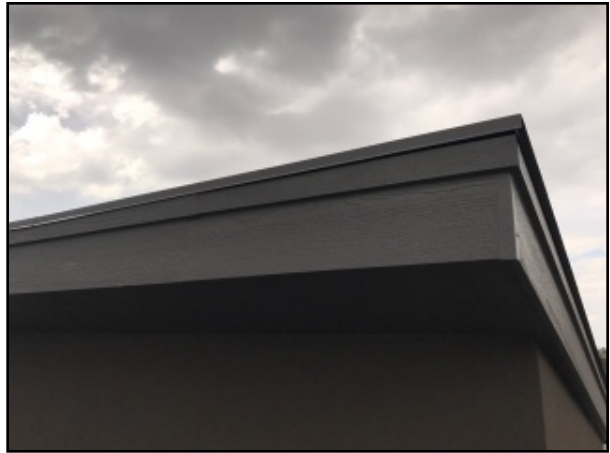
Z flashing on very top roof for dimensional shingles does not properly cover attic or roof.

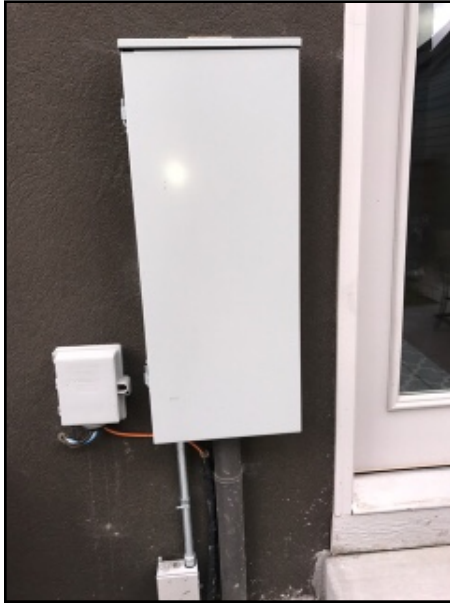
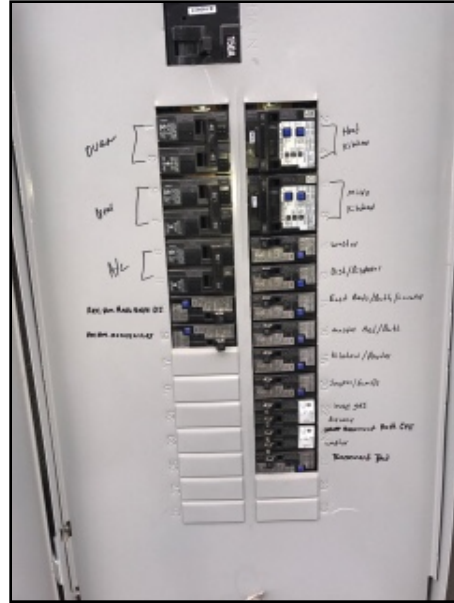
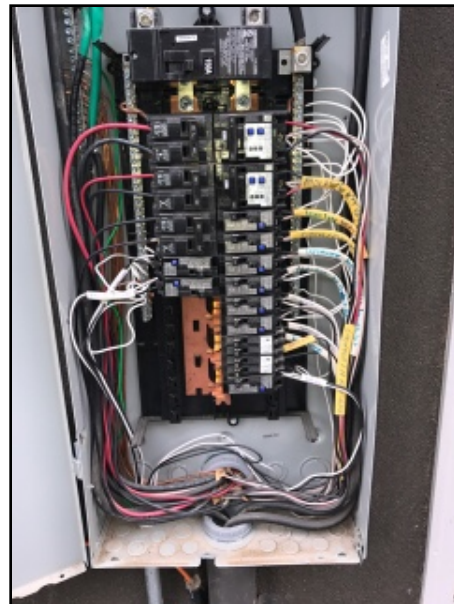
Recommend buyer/purchaser check labeling of breakers to ensure proper circuitry.

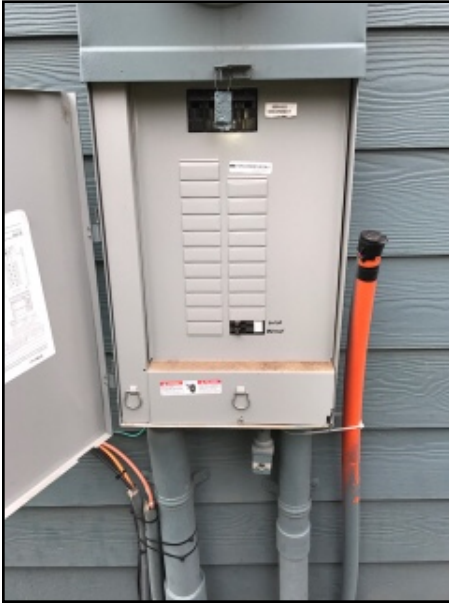
Figure 8-1

Recommend buyer/purchaser check labeling of breakers to ensure proper circuitry.

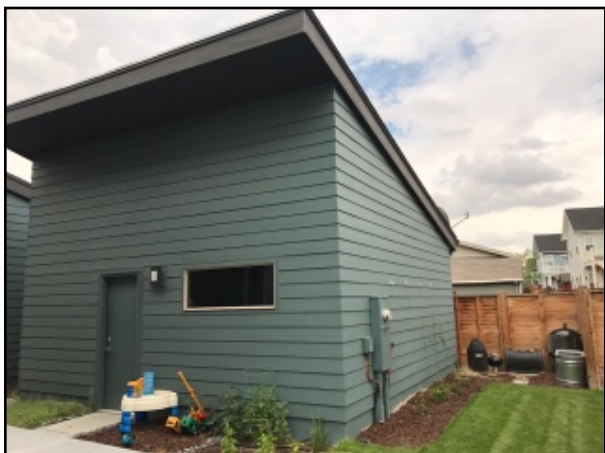
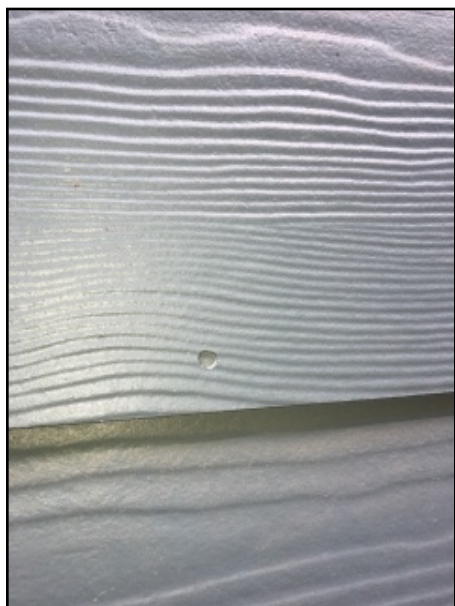
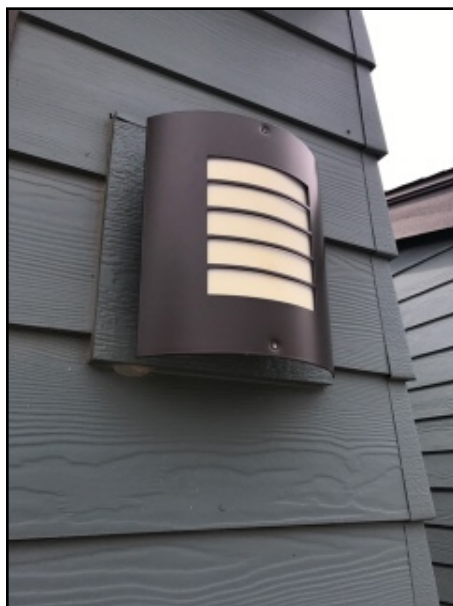
Comment 10:
Exterior lights on garage do not fully cover junction box behind fixture. This will allow moisture to enter.

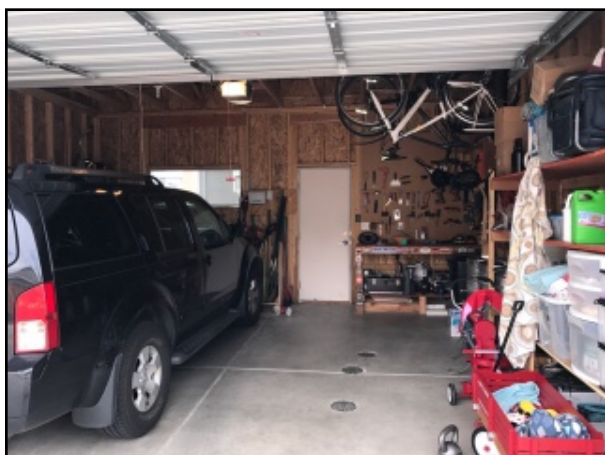
Figure 11-1

Recommend removing the rope knob/tee from garage door. This is a safety issue because it is an easy way for a thief to access your home. By pushing the top of door in, thieves can reach in with a wire and grab the rope/tee.

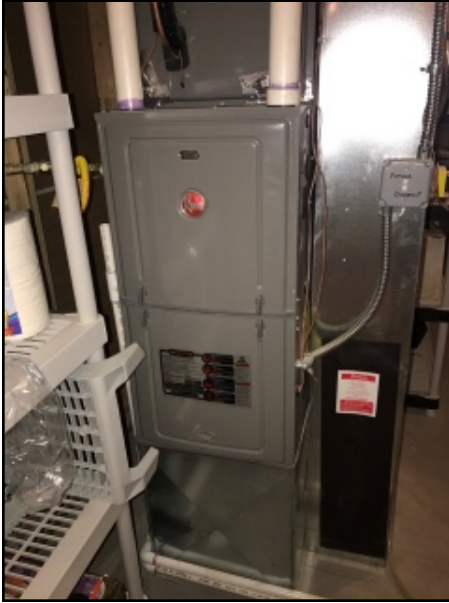
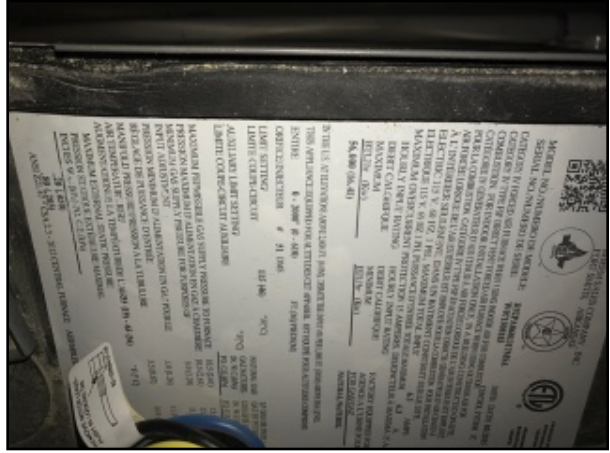
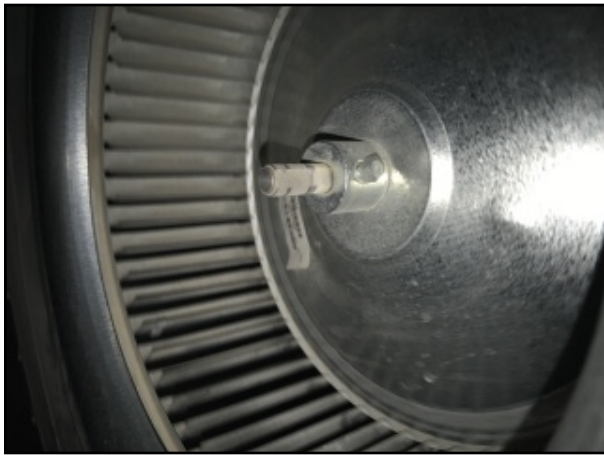
Furnace does not appear to have been cleaned/serviced annually. Recommend having a licensed HVAC technician fully evaluate, clean, service, and certify (the certification means pulling the blower motor and fan out of the unit and cleaning) system, and correct any other issues as needed. It is recommended that all HVAC systems be cleaned and serviced annually.

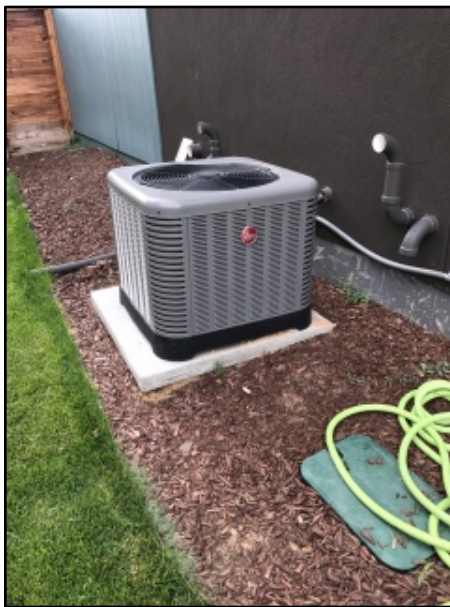
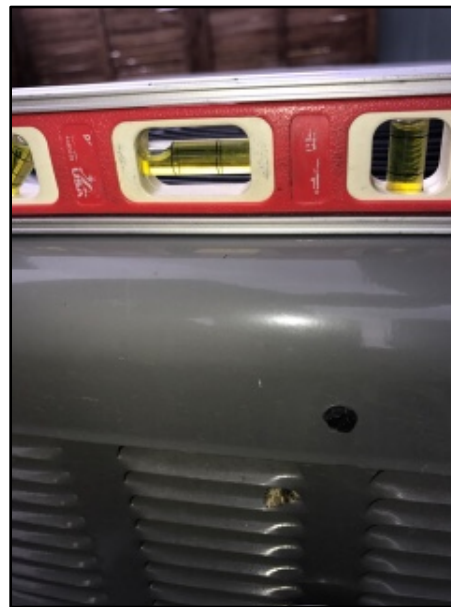
A/C compressor not level. This puts wear on moving components. Recommend leveling.

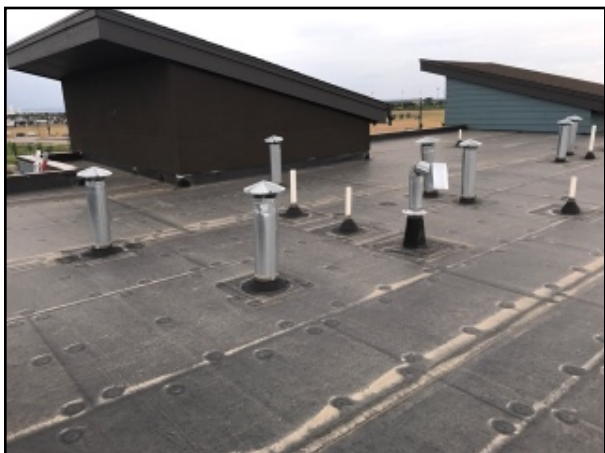
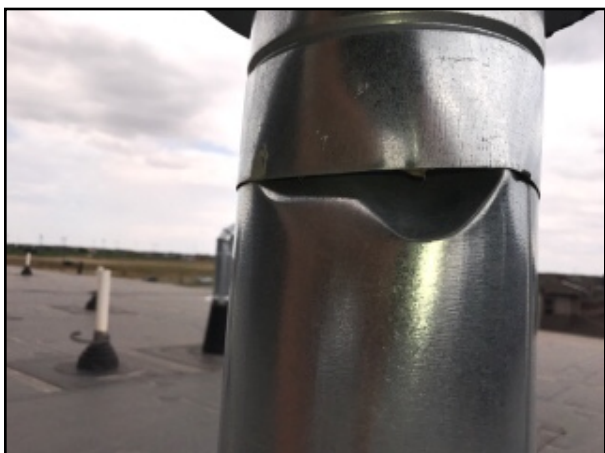
Many of the flue pipes are damaged where flue pipes are connected. This can allow bees, wasps and birds to enter and make nest that may prevent flue pipes from venting properly.

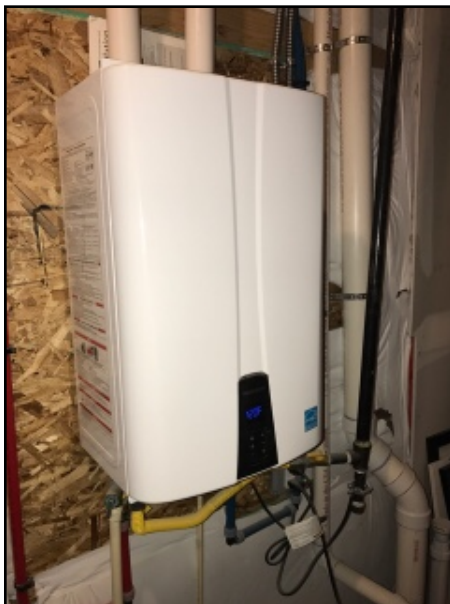
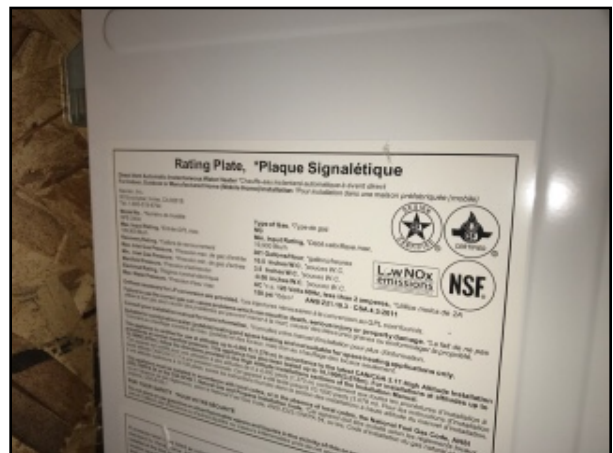
Unable to test hot water on demand unit(s). The only method of testing unit is turning on the hot water at each fixture and checking. Recommend getting a home warranty to cover unit in case of issues that may come up with these types of water heaters.
