Eagle Property Inspection Report

Property Address:

Sunnyside Rd

Inspected on Mon, Jul 24 2017 at 3:00 PM

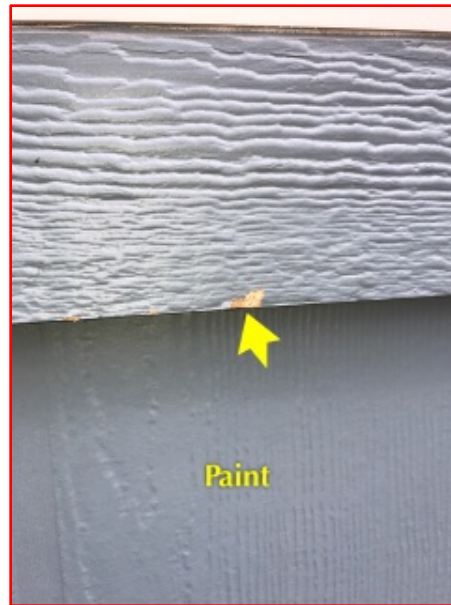
Figure 1-2

1) Paint needed to trim, siding, soffits, fascia, and any other wood components around house to protect material from moisture. This includes the bottom sides of siding/trim and other wood components on exterior. Recommend caulking any voids around penetrations into the wall, and around windows and doors. This will help provide a seal in these voids that would otherwise allow moisture to penetrate.

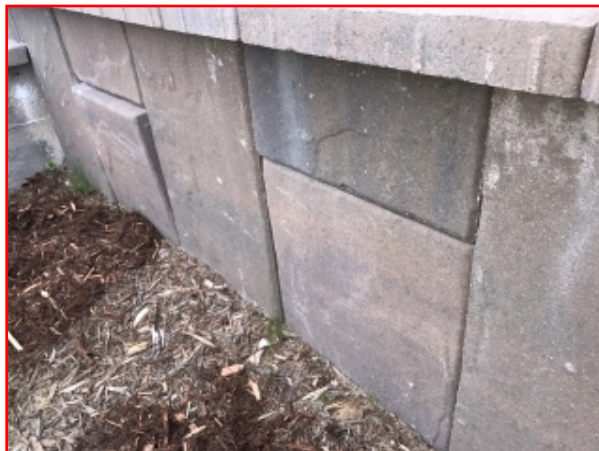
Figure 4-2

4) Several of the pavers around the front porch are loose, dislodged.

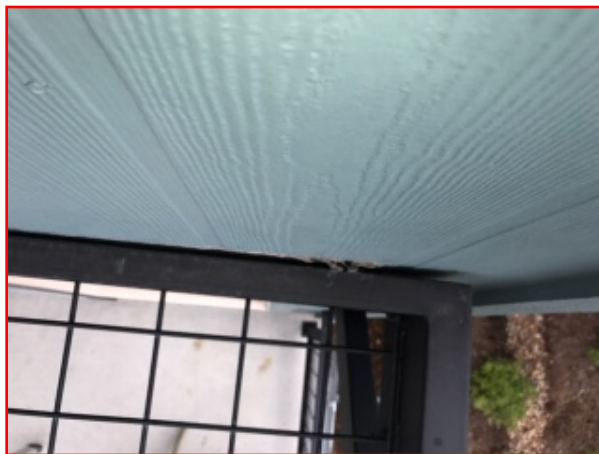
Figure 5-2

5) Metal awning appears to be pulling away from the side of the house.

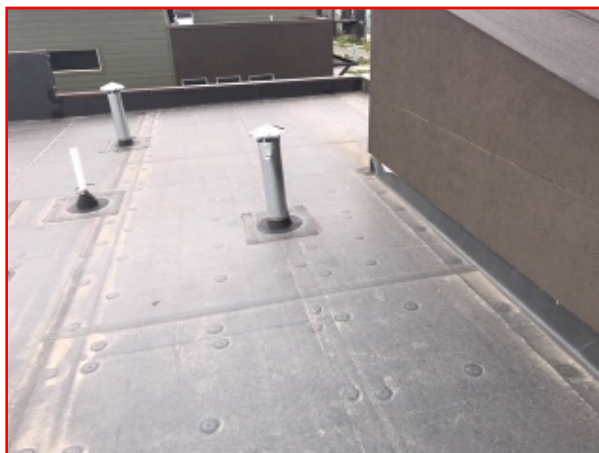
Figure 6-2

Z flashing on very top roof for dimensional shingles does not properly cover attic or roof.

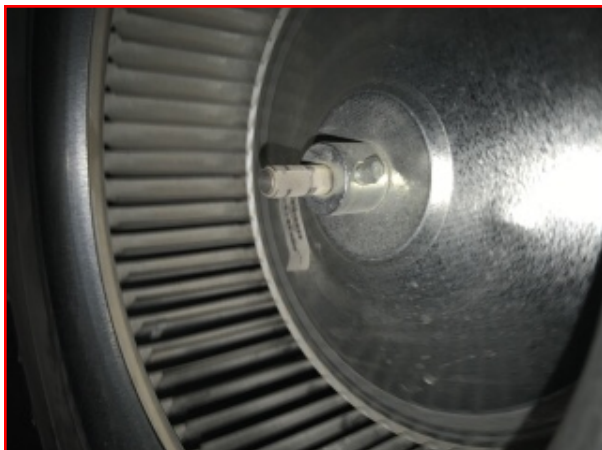
Figure 13-3

8) Furnace does not appear to have been cleaned/serviced annually. Recommend having a licensed HVAC technician fully evaluate, clean, service, and certify (the certification means pulling the blower motor and fan out of the unit and cleaning) system, and correct any other issues as needed. It is recommended that all HVAC systems be cleaned and serviced annually.

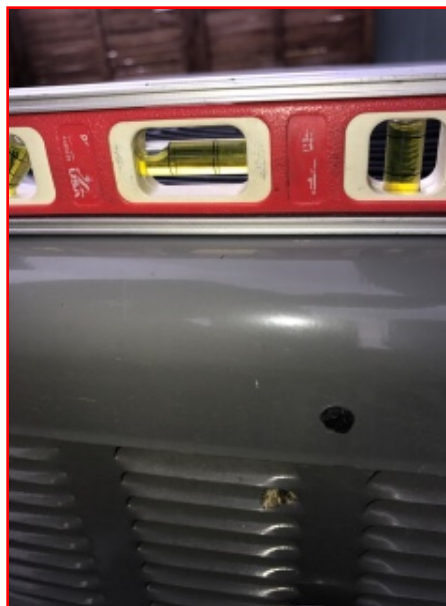
Figure 16-2

9) A/C compressor not level. This puts wear on moving components. Recommend leveling.

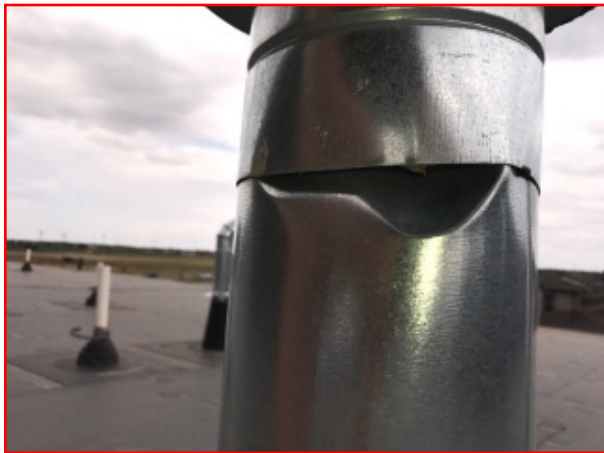
Figure 18-3

11) Many of the flue pipes are damaged where flue pipes are connected. This can allow bees, wasps and birds to enter and make nest that may prevent flue pipes from venting properly.

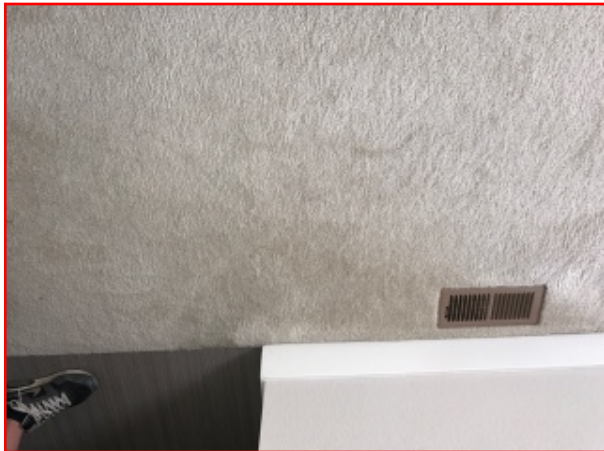
Figure 29-1

12) Sub-floor between master bedroom and bathroom squeaks. It does not appear that the sub-floor was properly liquid nailed down or nailed properly.

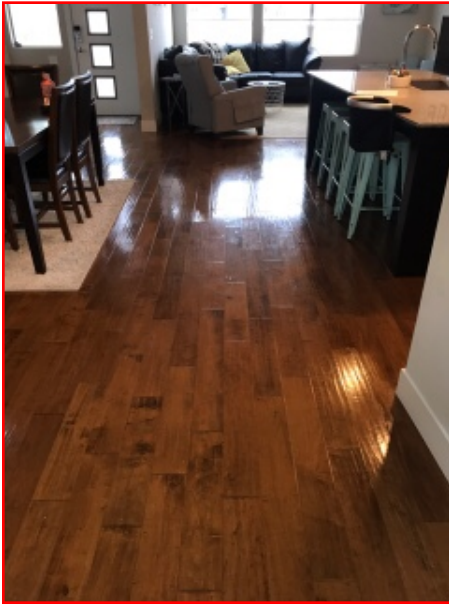
Figure 30-1

13) Wood floors are drying and separating at joints. Flooring is popping and do not appear to have been glued down properly. Wood floors may not have been acclimated properly. Wood floors will need removed and re-installed to fix/correct the problem.

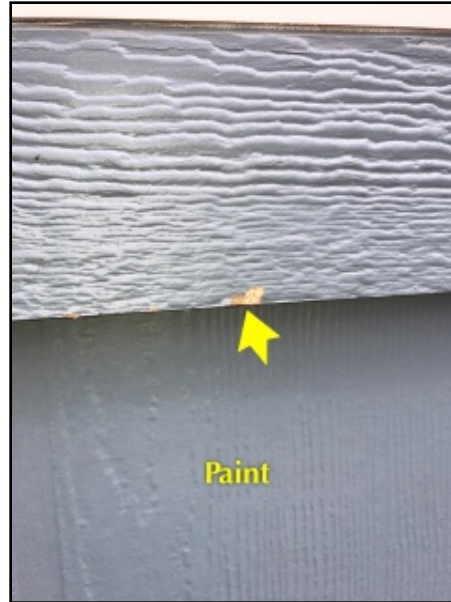
Figure 1-2

Paint needed to trim, siding, soffits, fascia, and any other wood components around house to protect material from moisture. This includes the bottom sides of siding/trim and other wood components on exterior. Recommend caulking any voids around penetrations into the wall, and around windows and doors. This will help provide a seal in these voids that would otherwise allow moisture to penetrate.

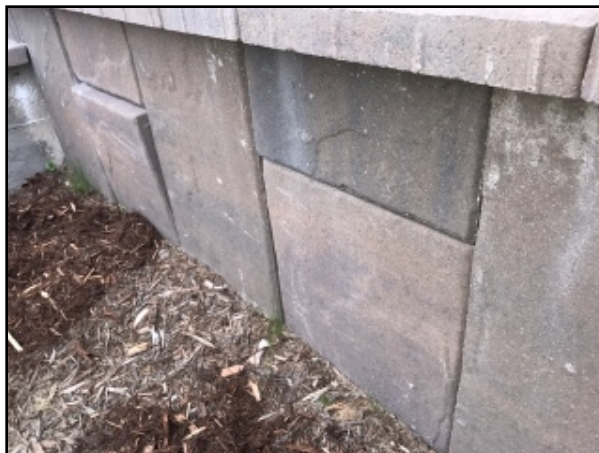
Figure 4-2

Several of the pavers around the front porch are loose, dislodged.

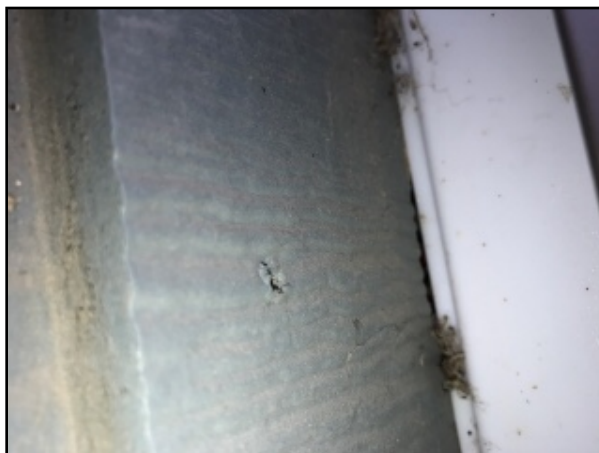
Figure 10-2

Comment 10:
Exterior lights on garage do not fully cover junction box behind fixture. This will allow moisture to enter.

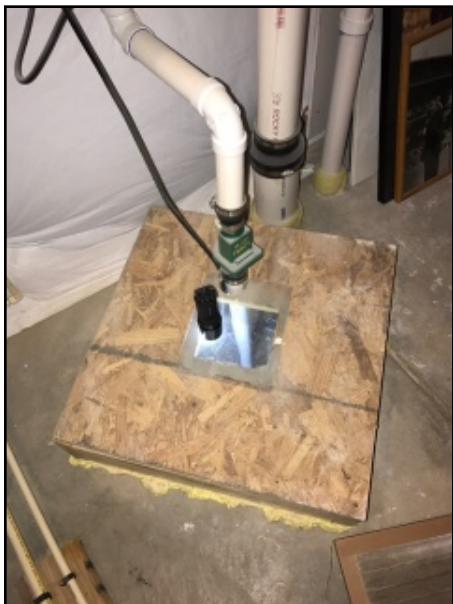
Figure 12-1

Comment 12:
Sump pit was dry at time of inspection.

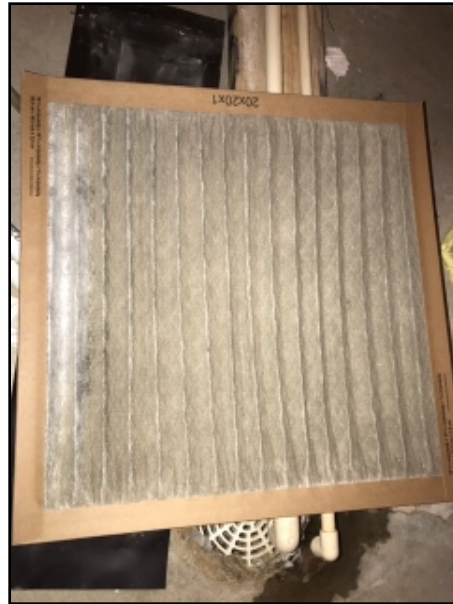
Figure 13-4

Furnace does not appear to have been cleaned/serviced annually. Recommend having a licensed HVAC technician fully evaluate, clean, service, and certify (the certification means pulling the blower motor and fan out of the unit and cleaning) system, and correct any other issues as needed. It is recommended that all HVAC systems be cleaned and serviced annually.

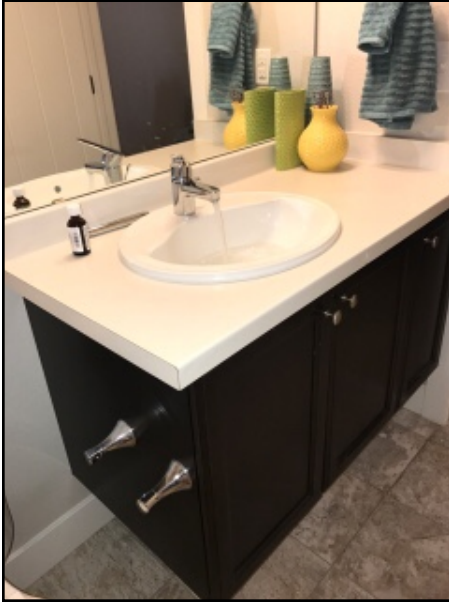
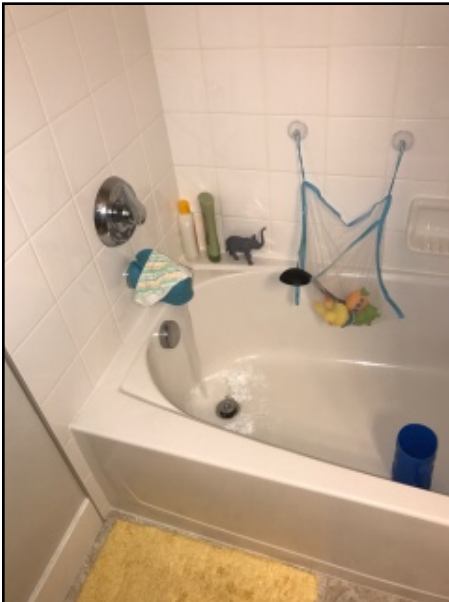
Bathroom appears in good working condition. There were no leaks found at time of inspection.

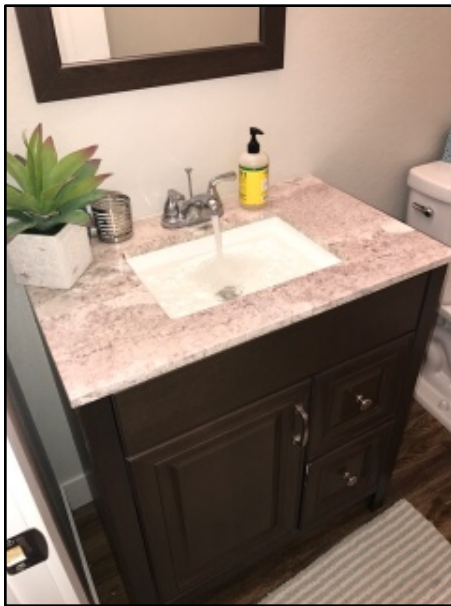
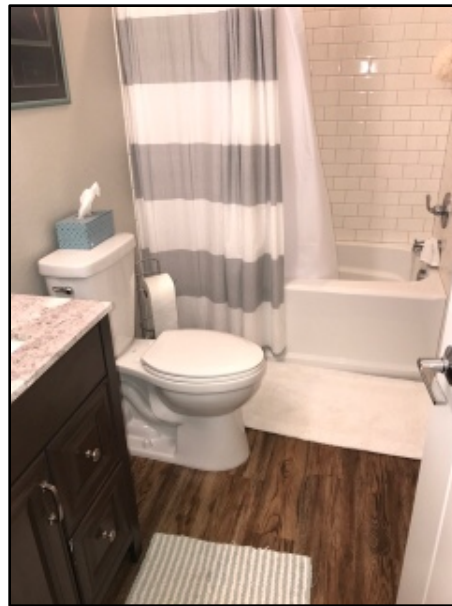
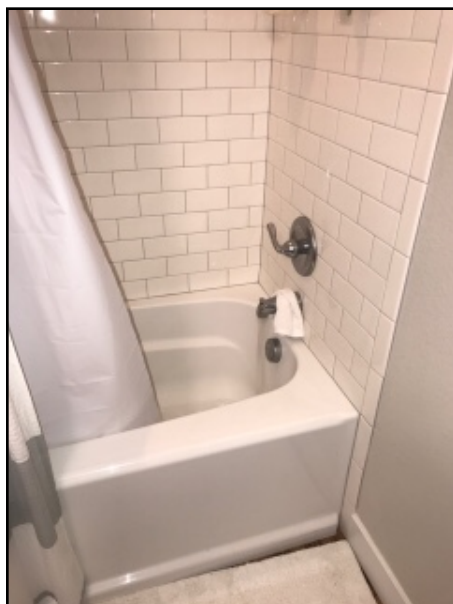
Basement bathroom appears serviceable. There were no leaks at time of inspection.

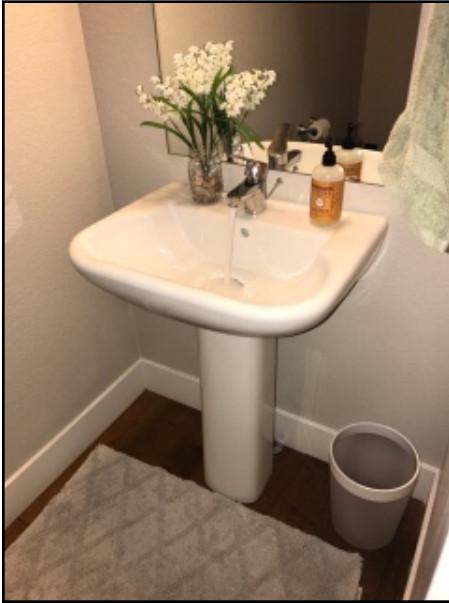
**Comment 24:**
Powder room appears serviceable. No leaks detected at time of inspection.

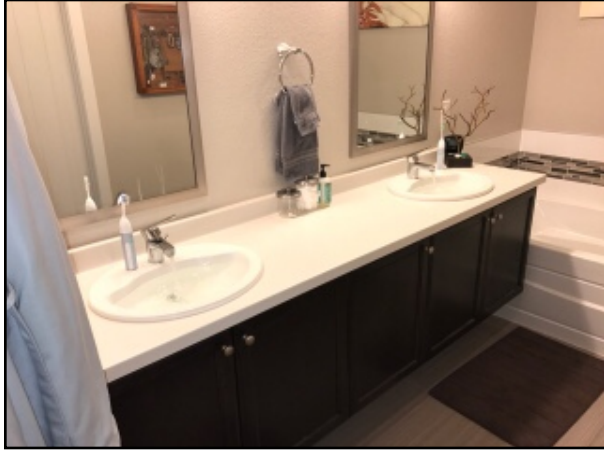
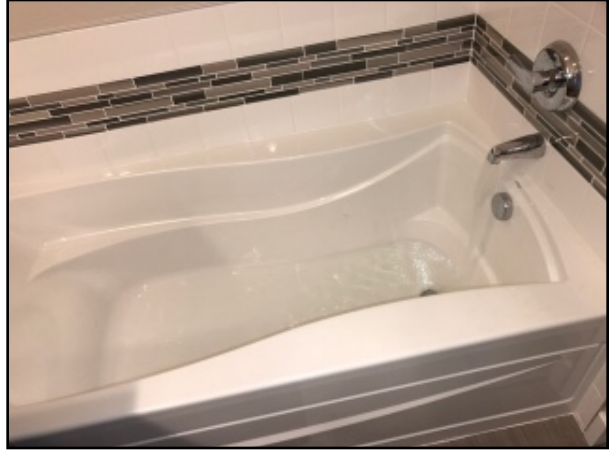
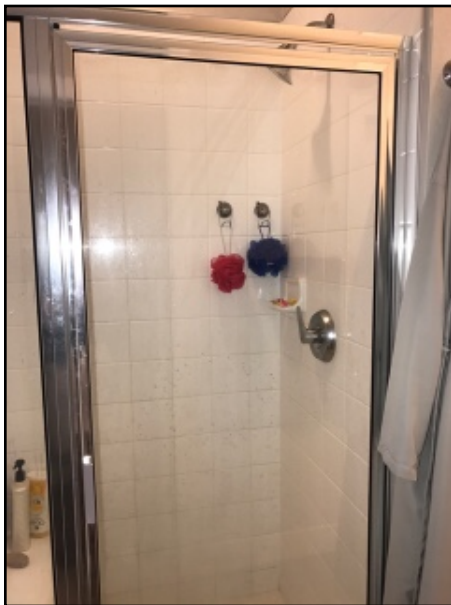
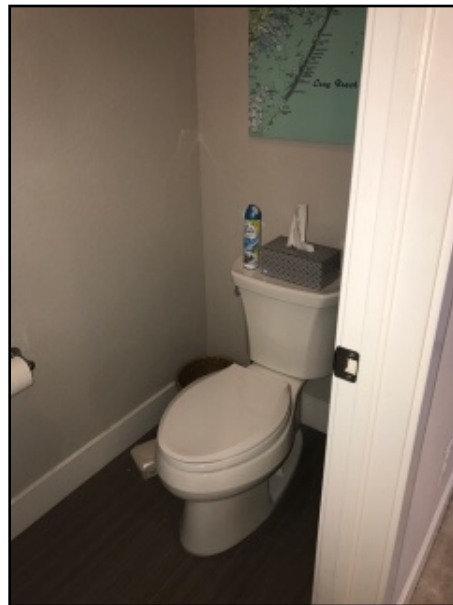
Master bathroom appears serviceable. No leaks discovered at time of inspection.

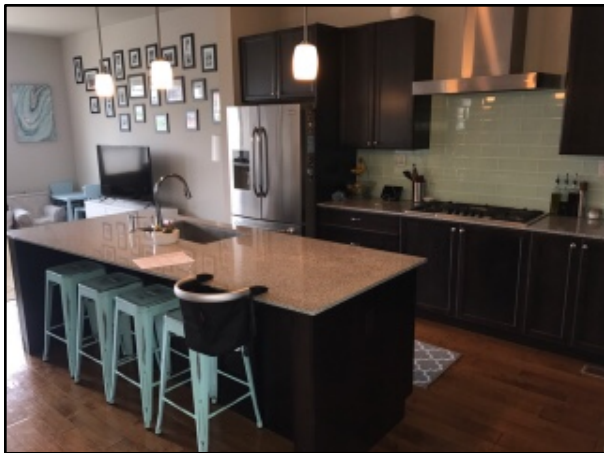
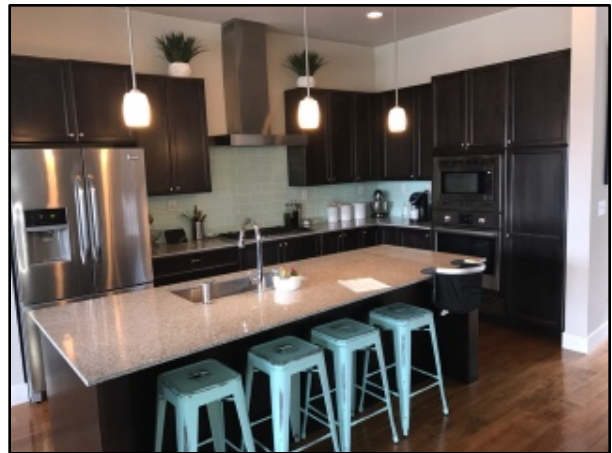
Kitchen appears serviceable. No leaks at time of inspection.

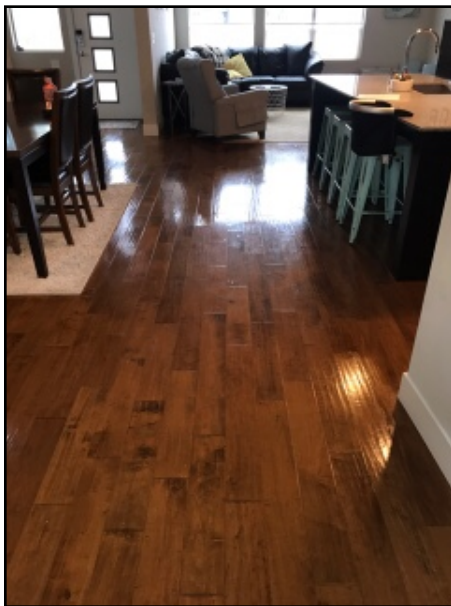
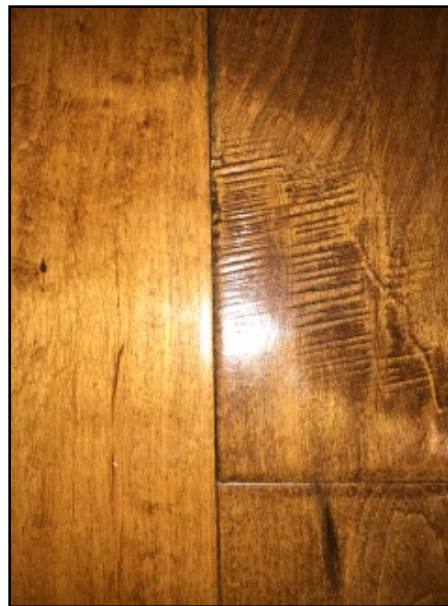
Wood floors are drying and separating at joints. Flooring is popping and do not appear to have been glued down properly. Wood floors may not have been acclimated properly. Wood floors will need removed and re-installed to fix/correct the problem.
